Brake Literature / BRAKE Squeal

Regarding Brake Squeal

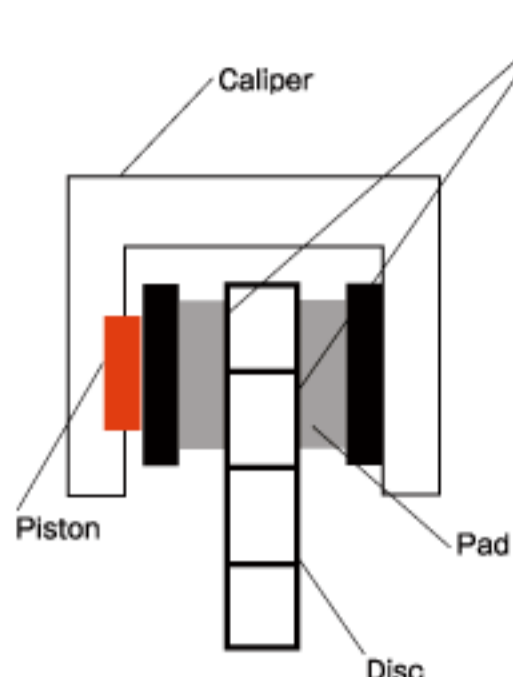
By braking operation, contact vibration caused between pad and disc touch (vibration = natural frequency = sound) will be amplified by disc body to amplified as larger sound (disc itself functioned as speaker and enlarge the sound) Brake squeal can be explained in the illustration as follows.

When brake applied, pad pushed by piston, contact with disc. There is no problem when strong and uniformed pressure applied, however in reality it will not happen and vibration occur (judder). Such judder amplified by disc and in the worst case it transferred to caliper and suspension, further widely to vehicle body, also become variety of noise.

1. Absorbed by pad material softness (attenuation characteristics)
 2. Absorbed by disc softness (attenuation characteristics)
 3. Absorbed by the shim between pad back plate and piston.
- Should absorption not effective -> **become larger and unpleasant noise (claim)**

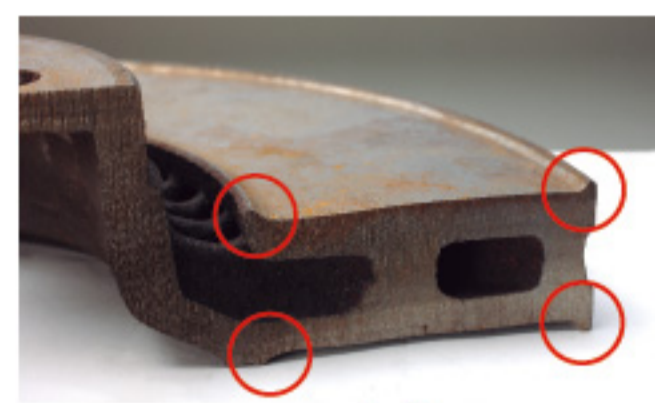
Case1

Continue to utilise used disc, replaced only new pad. Right after the replacement the squeal start. Since pad replaced, the cause must be on the pad. However there is no abnormality shown on the pad. Inspected for various possible causes, not fully understood. While careful inspection of disc, the disc edge (area circulated by red ink) sharply pointed is noticed.

Firstly, in the case 1, since the new pad applied naturally the friction surface being fully flat. Then combined with used disc having sharply pointed edge (area circulated in red ink) alone touch against and rubbed as scratched by nail, start squeal. Only the very small portion of disc touched and cautious for very poor effect.

Further, both in the case 1 and case 2, not only the pad replacement, grinding of disc or replacement to new disc virtually stop the squeal.

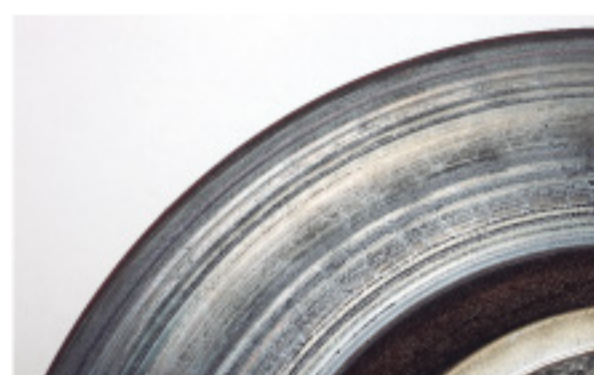
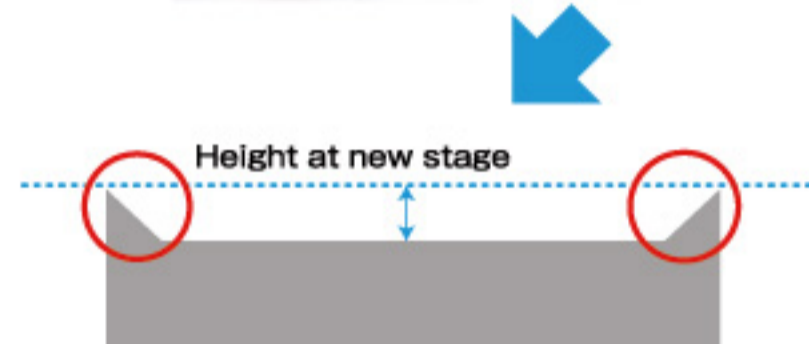
Case2

Continued to utilise used disc, replaced only new pad. Right after the replacement the squeal start. Since pad replaced, the cause must be on the pad. However there is no abnormality shown on the pad. Inspected for various possible causes, not fully understood. While there is no abnormality shown on the pad, surface of the disc has friction material left over and deposit from previously used pad, and further, steps created.

Next, in the case 2, while friction material adhered to disc surface, such area alone exclusively dragged and cause squeal. Or, there are steps, pad and disc will not adhere tightly and vibration appeared to create squeal.

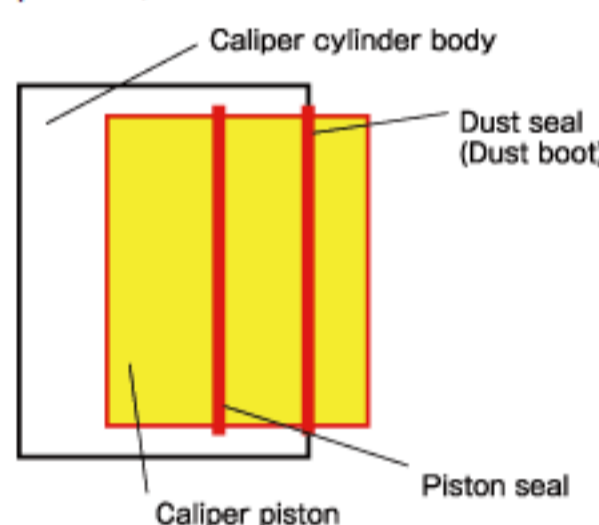
To continue, we would like to explain on caliper piston which deeply related to brake squeal. Caliper piston is not only for brake squeal, but also related in brake problem, however over looked without questioning often. Firstly, please carefully look at the illustration of caliper piston.

As shown in the illustration, caliper piston being held in cylinder body with piston seal. Then, by elasticity by the piston seal, pad to be pulled back when brake released, however, such elasticity lost releasing between pad and disc become poor, drag start. Moreover, not only such, vibration absorption become poor, pad vibration can easily transferred to caliper itself, encourage squeal. Now, it is understood that piston seal or dust boot being the important compartment, and when they deteriorated various harming occur but, most people have never experienced replacing them. Generally, it being said as replace once at each 100,000km run, depend upon living area or driving style. For those drive pretty hard need quicker replacement, it is best to replace once every 5 running events for circuit run drivers. Who never replaced seal (boot) once, people with longer running distance hearing problems such as squeal etc, we recommend replacement. Possibility of curing of symptoms is very high.

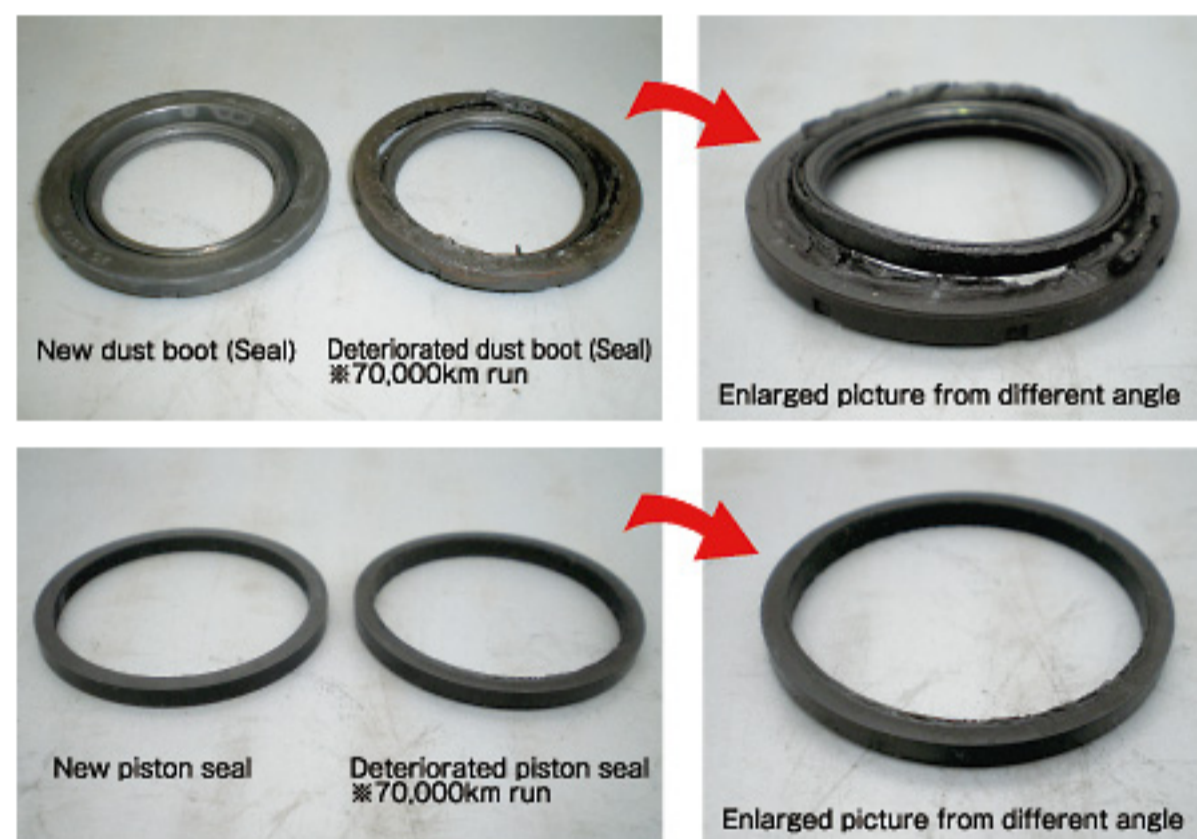
Surely you will be surprised to see such parts may cause the brake squeal. But, observation at these detracted parts make you understood. Questioning on replaced parts is not fault, and natural idea, it is very short minded to question replaced parts alone. At the same time with inspecting replaced parts, check for abnormality on parts not replaced, check for deteriorated parts may be the shortest way to solve brake squeal.
